ALPINE TEST SITE GÜTSCH: MONITORING OF A WIND TURBINE UNDER ICING CONDITIONS

In 2004, an Enercon E-40 wind turbine with blade heating was installed on Gütsch mountain, Switzerland, at 2'300 m asl. A test station of the Swiss meteorological network SwissMetNet was installed nearby in 2003. The proximity of the two facilities operating under icing conditions led to the launch of the research project "Alpine Test Site Gütsch" which is embedded in the European "COST Action 727".

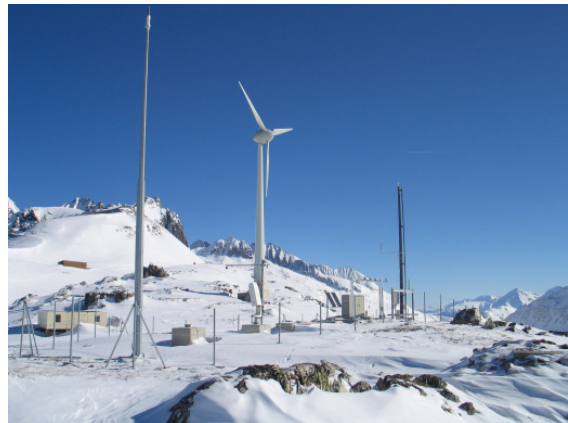
Fig. 1: Alpine Test Site Gütsch.

In 2004, a 600 kW Enercon E-40 wind turbine with integrated blade heating was installed on Gütsch mountain, central Switzerland, at 2'300 m asl. Coincidentally, a fully equipped test station of the Swiss meteorological network SwissMetNet was installed about 200 m away from the wind turbine in 2003 (Fig. 1).

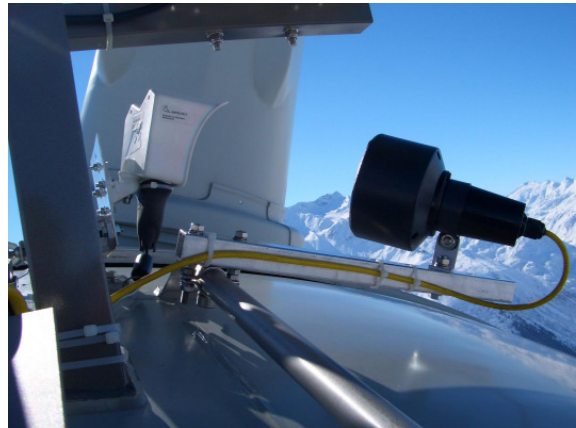
Fig. 3: Web cam mounted on the nacelle of the wind turbine. The lamp on the right is for heating purposes

The availability of continuous live images of the wind turbine's blades is crucial for the performance analysis under icing conditions. During recent projects, the cameras were installed inside or outside the hub pointing towards the blade [3]. In this project, another approach was developed: A commercially available Mobotix web cam was installed on the nacelle of the wind turbine (Fig. 3).

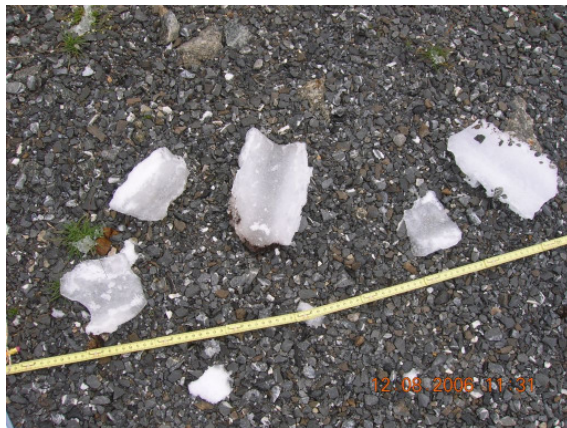
Fig. 5: Ice fragments from the E-40 wind turbine.

As the wind turbine is located close to ski slopes, ice throw is an important safety issue [4]. The area around the wind turbine was inspected after every icing event for ice fragments that had fallen off the blades. Distance from and direction relative to the turbine as well as size and weight of the recovered fragments were mapped and, together with photos (Fig. 5), collected in a data base.
